Quality Assurance and Source Inspection

Contract #: 04-0120F4Cty: SF/ALA Rte: 80 PM: 13.2/13.9File #: 69.28**WELDING INSPECTION REPORT****Resident Engineer:**Pursell, Gary**Address:** 333 Burma Road**City:** Oakland, CA 94607**Report No:** WIR-016359**Date Inspected:** 07-Aug-2010**Project Name:** SAS Superstructure**OSM Arrival Time:** 700**Prime Contractor:** American Bridge/Fluor Enterprises, a JV**OSM Departure Time:** 1900**Contractor:** Zhenhua Port Machinery Company, Ltd (ZPMC), Changxing Island **Location:** Shanghai, China**CWI Name:** Qiu Wen**CWI Present:** Yes No**Inspected CWI report:** Yes No N/A**Rod Oven in Use:** Yes No N/A**Electrode to specification:** Yes No N/A**Weld Procedures Followed:** Yes No N/A**Qualified Welders:** Yes No N/A**Verified Joint Fit-up:** Yes No N/A**Approved Drawings:** Yes No N/A**Approved WPS:** Yes No N/A**Delayed / Cancelled:** Yes No N/A**Bridge No:** 34-0006**Component:** Tower & OBG Components**Summary of Items Observed:**

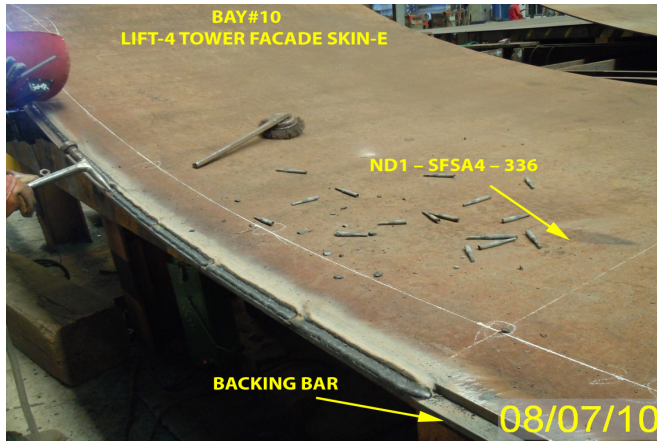
Weld build up being performed using backing bar located on Lift-4 skin-E Facade ND1 – SFSA4 – 336 as per the Weld Repair report # T-WR3477. Welder is identified as 053829. ZPMC Quality Control (QC) Inspector is identified as Jiang Xiao Bao. The welding variables recorded by QC appeared to comply with the WPS – 345 – FCAW – 2G (2F) – Repair – 1. (See attached Photo)

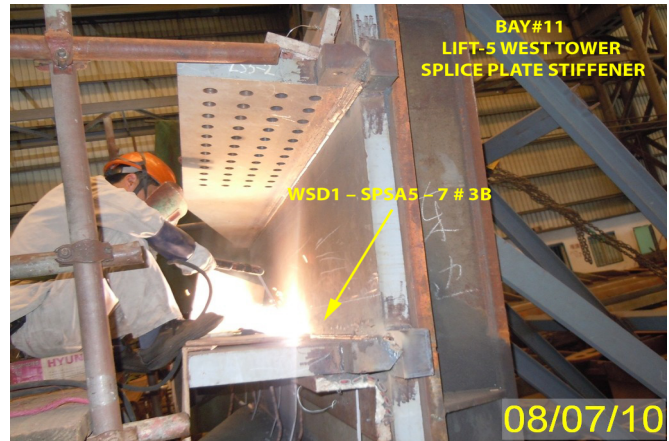
Weld joint # 3B located on Lift-5 Splice Plate Stiffener WSD1 – SPSA5 – 7. Welder is identified as 040656. ZPMC Quality Control (QC) Inspector is identified as Liu Dao Feng. The welding variables recorded by QC appeared to comply with the WPS – B – T – 3211 – Tc – U5b – 1. (See attached Photo)
